**Flood Control Project Maintenance  
Levee Inspections**

**Fall 2018 Levee Maintenance Deficiency Summary Report**

**Levee Inspection Report By Mile - Fall 2018**

**Sutter Maintenance Yard Maintenance Area 0003**

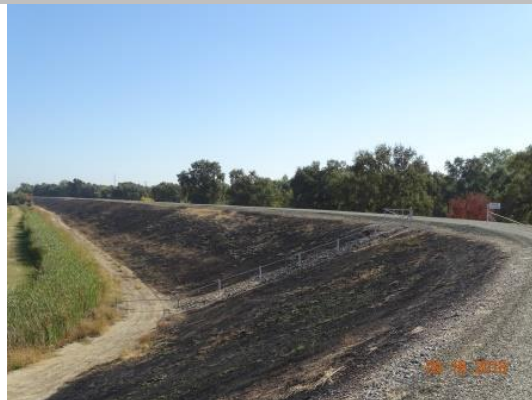
Photo 1 of 1 : FA\_2018\_MA0003\_195\_8\_20181003\_00020.jpg

LM Start	0.00	Rating **	A	Issue No.	8
LM End	5.10	Issue Type +	Ma	Location *	LS
Category	Earthen Levee			GPS Latitude/Longitude	
				Start	End
Item	Vegetation			38.898123 °	38.950796 °
				-121.617970 °	-121.585792 °
DWR ID	DWR_MA0003_01_f_2018_8				
Comment Code					
V1 : Control annual grass and weeds on the levee slopes and easements.					
Inspector Comment					
Annual vegetation is well maintained, Fall 2018.

View looking upstream landside of the well maintained vegetation, Fall 2018.

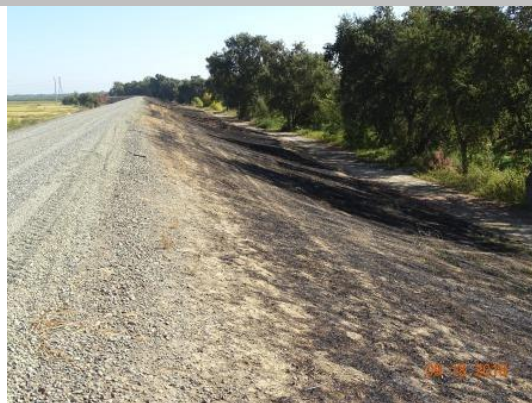
Photo 1 of 1 : FA\_2018\_MA0003\_195\_9\_20181003\_00019.jpg

LM Start	0.00	Rating **	A	Issue No.	9
LM End	5.10	Issue Type +	Ma	Location *	WS
Category	Earthen Levee			GPS Latitude/Longitude	
				Start	End
Item	Vegetation			38.898123 °	38.950796 °
				-121.617970 °	-121.585792 °
DWR ID	DWR_MA0003_01_f_2018_9				
Comment Code					
V1 : Control annual grass and weeds on the levee slopes and easements.					
Inspector Comment					
Annual vegetation is well maintained, Fall 2018.

View looking upstream waterside of the well maintained vegetation, Fall 2018.

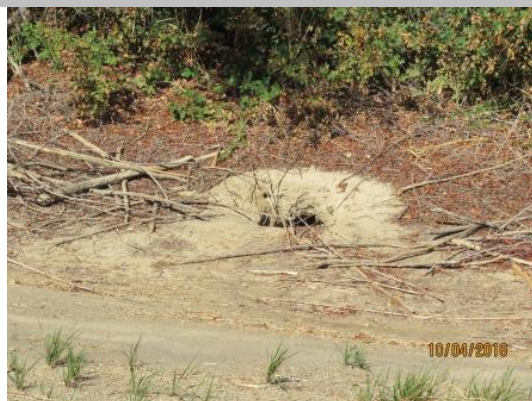
Photo 2 of 2 : FA\_2018\_MA0003\_195\_140\_20180918\_00006.jpg

LM Start	0.78	Rating **	A/W	Issue No.	140 (cont)	
LM End	0.78	Issue Type +	Ma	Location *	LS	
Category	Earthen Levee			GPS Latitude/Longitude		
				Start		End
Item	Animal Control			38.903339 °		38.903339 °
				-121.606209 °		-121.606209 °
DWR ID	DWR_MA0003_01_f_2014_140					
Comment Code						
A3 : No rodents visible, but rodent burrows visible; need to backfill and compact or grout burrows.						
Inspector Comment						
The rodent hole on the landward toe road was approximately 8" in diameter the hole is no longer there but should be monitored. Fall 2018.

This photo was taken from the landward levee slope near the toe road facing north looking at an approximately 8" rodent hole. Fall 2016.

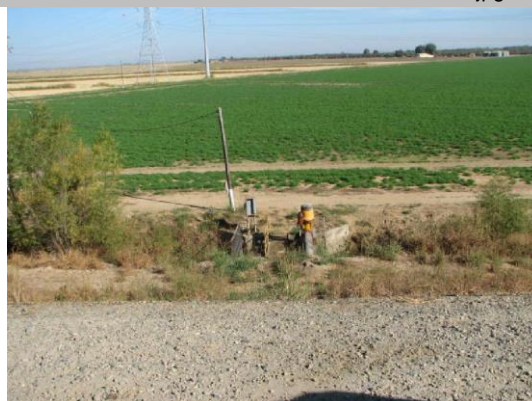
Photo 1 of 3 : UCIP\_FA\_2018\_53409\_64649.jpg

UCIP Comments: 10/04/2018 Sink hole observed between the dual 18-inch pipes located on the LS near the concrete headwall. Erosion was also observed behind the concrete headwall located on the LS. Inlet of dual 18-inch pipes was still covered by filled sandbags. Crossing remains Urgent due to the sink hole and erosion visible on the LS. These crossings were recommended for replacement under the SBFCA project; however, no work has been done to date. Recommend monitoring site and coordinating with SBFCA to determine the status of the project. (O. Magana - DWR UCIP)

4/11/2017 Water levels were high on WS during inspection so pipe ends could not be inspected. Believe that the sandbags are still in place and condition of flap gates is unknown. (DWR Sutter Yard - afreitag)10/10/2016 WS pipe end was underwater for inspection but the sandbags still appear to be in place. (DWR Sutter Yard - afreitag)4/18/2016 No repairs have been made to the pipe yet. (DWR Sutter Yard - afreitag)5/12/2015 Water level high in WS ditch so could not see WS end of crossing. Do not believe that repairs have been made yet. (DWR Sutter Yard - afreitag)11/17/2014 Same as last inspection. (DWR Sutter Yard - afreitag)5/14/2014 Same as last inspection. (DWR Sutter Yard - afreitag)10/30/2013 Same as last inspection. (DWR Sutter Yard - afreitag)5/21/2013 SBFCA project recommends replacing in accordance with title 23. High water levels in WS ditch have pipe ends underwater but repairs have not yet been completed but are planned for when water levels drop. (DWR Sutter Yard - afreitag)10/10/2012 Flap gates not visible on waterward headwall and it appears as though they have been replaced by sandbags. Slide gates on LS appear to be closed yet water leaks excessively from the WS at the sandbagged headwall. (DWR UCIP - W. Wylie)

Concrete headwall with walkway and slide gates at LS toe.

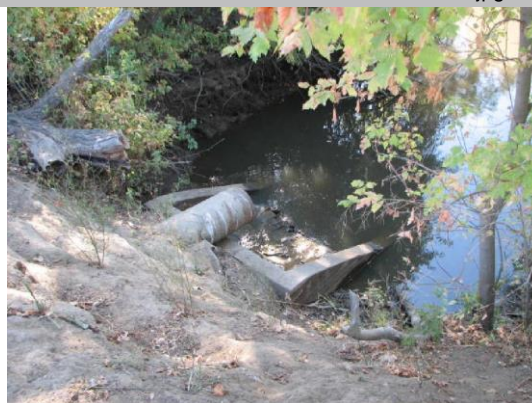
Photo 2 of 3 : UCIP\_FA\_2018\_53409\_64648.jpg

UCIP Comments: 10/04/2018 Sink hole observed between the dual 18-inch pipes located on the LS near the concrete headwall. Erosion was also observed behind the concrete headwall located on the LS. Inlet of dual 18-inch pipes was still covered by filled sandbags. Crossing remains Urgent due to the sink hole and erosion visible on the LS. These crossings were recommended for replacement under the SBFCA project; however, no work has been done to date. Recommend monitoring site and coordinating with SBFCA to determine the status of the project. (O. Magana - DWR UCIP)

Concrete U shaped headwall on WS toe filled in with Sandbags. 16-inch pipe shown over top of headwall.

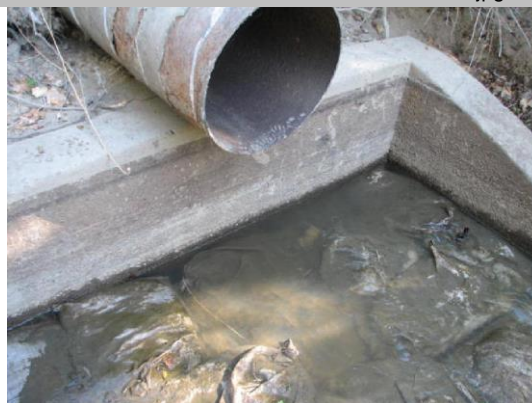
Photo 3 of 3 : UCIP\_FA\_2018\_53409\_64647.jpg

UCIP Comments: 10/04/2018 Sink hole observed between the dual 18-inch pipes located on the LS near the concrete headwall. Erosion was also observed behind the concrete headwall located on the LS. Inlet of dual 18-inch pipes was still covered by filled sandbags. Crossing remains Urgent due to the sink hole and erosion visible on the LS. These crossings were recommended for replacement under the SBFCA project; however, no work has been done to date. Recommend monitoring site and coordinating with SBFCA to determine the status of the project. (O. Magana - DWR UCIP)

Concrete U shaped headwall filled in with sandbags on WS toe. Flap gates appear to be missing and water readily flows through the sandbags from LS.

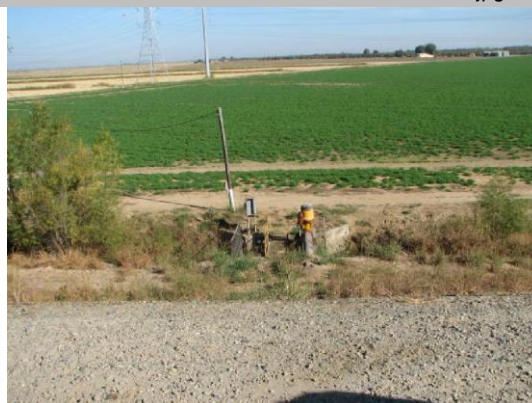
Photo 1 of 3 : UCIP\_FA\_2018\_53414\_64662.jpg

UCIP Comments: 10/04/2018 Sink hole observed between the dual 18-inch pipes located on the LS near the concrete headwall. Erosion was also observed behind the concrete headwall located on the LS. Inlet of dual 18-inch pipes was still covered by filled sandbags. Crossing remains Urgent due to the sink hole and erosion visible on the LS. These crossings were recommended for replacement under the SBFCA project; however, no work has been done to date. Recommend monitoring site and coordinating with SBFCA to determine the status of the project. (O. Magana - DWR UCIP)

Concrete headwall, slidegates, and metal walkway on LS toe.

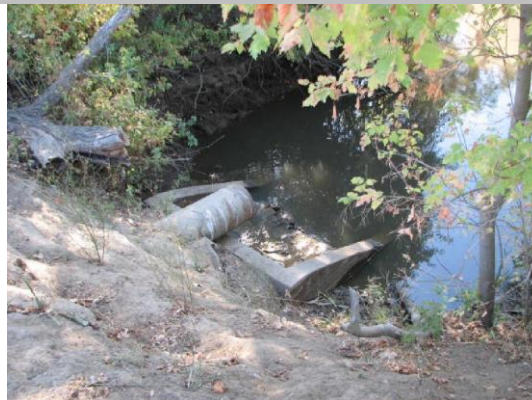
Photo 2 of 3 : UCIP\_FA\_2018\_53414\_64661.jpg

UCIP Comments: 10/04/2018 Sink hole observed between the dual 18-inch pipes located on the LS near the concrete headwall. Erosion was also observed behind the concrete headwall located on the LS. Inlet of dual 18-inch pipes was still covered by filled sandbags. Crossing remains Urgent due to the sink hole and erosion visible on the LS. These crossings were recommended for replacement under the SBFCA project; however, no work has been done to date. Recommend monitoring site and coordinating with SBFCA to determine the status of the project. (O. Magana - DWR UCIP)

Concrete U shaped headwall on WS toe filled with sandbags.

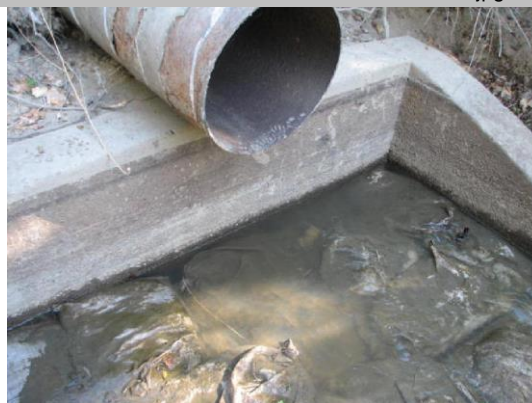
Photo 3 of 3 : UCIP\_FA\_2018\_53414\_64660.jpg

UCIP Comments: 10/04/2018 Sink hole observed between the dual 18-inch pipes located on the LS near the concrete headwall. Erosion was also observed behind the concrete headwall located on the LS. Inlet of dual 18-inch pipes was still covered by filled sandbags. Crossing remains Urgent due to the sink hole and erosion visible on the LS. These crossings were recommended for replacement under the SBFCA project; however, no work has been done to date. Recommend monitoring site and coordinating with SBFCA to determine the status of the project. (O. Magana - DWR UCIP)

Flap gates appear to be missing from U shaped headwall. Sandbags fill headwall but water flows heavily from LS.

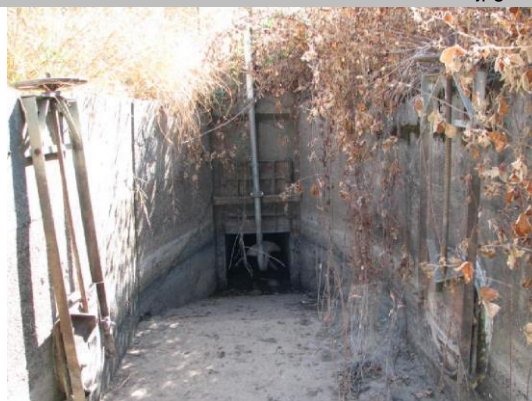
Photo 1 of 3 : UCIP\_FA\_2018\_53408\_64668.jpg

UCIP Comments: 10/04/2018 Cavity filled with rock is still intact. Unable to determine cause of cavity collapse. Photos taken from LS show some sediment buildup inside concrete culvert. The pipe is a straight through culvert that goes through a tall levee (about 25 feet tall). Recommend internal inspection to determine integrity condition of culvert through the levee. Crossing remains Urgent due to the cavity collapse observed during 2017 (unknown cause of failure) and the unknown condition of the culvert through the levee. Erosion and potential sink holes visible behind concrete box on the WS toe. (O. Magana - DWR UCIP)

4/11/2017 There was a cavity collapse above the pipe alignment on the WS slope during January 2017 high water event. Cavity was filled with rock to prevent further levee damage during the high water season. Further inspection will be needed on this crossing to determine the cause of the collapse. Recommend having an internal camera inspection done. Erosion happening around the WS concrete vault. (DWR Sutter Yard- A Freitag) 10/10/2016 LS pipe end was mostly submerged so could not verify the connectivity between the LS headwall and WS vault. Blackberries and still overgrown on WS. (DWR Sutter Yard - a Freitag) 4/18/2016 WS vault is being overgrown with blackberries. They should be sprayed and cleared back. No other problems were noticeable with this crossing. 5/12/2015 Only the right flapgate appeared to be abandoned. The left and middle flap gates were flowing water during the last inspection. 11/17/2014 Same as last inspection. 5/14/2014 Same as last inspection. 10/30/2013 Same as last inspection. 5/21/2013 Pumping plant was running and filling concrete vault on WS toe through the left flap gate and then flowing through levee pipe and filling irrigation ditch on LS. Left and middle flap gates appear to be connected to pumps and right gate appears abandoned. Recommend contacting owner to get more details. 10/10/2012 Pumping plant has been disconnected from levee. Need to determine if abandonment is appropriate or if this is now a gravity drain with flap gate. (DWR UCIP - W. Wylie)

32X32 box culvert on LS toe in Concrete U shaped channel with slide gate.

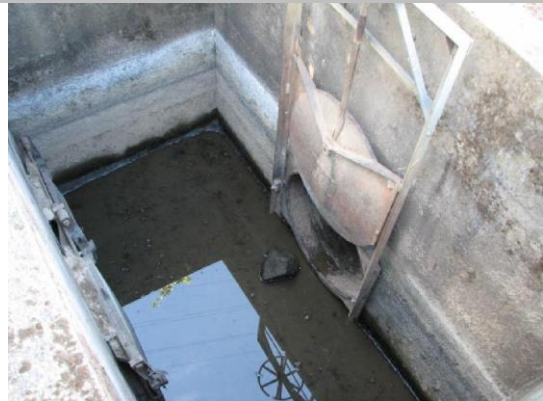
Photo 2 of 3 : UCIP\_FA\_2018\_53408\_64667.jpg

8-foot X 14-foot concrete box on WS toe with slide gate and 3 abandoned flap gates.

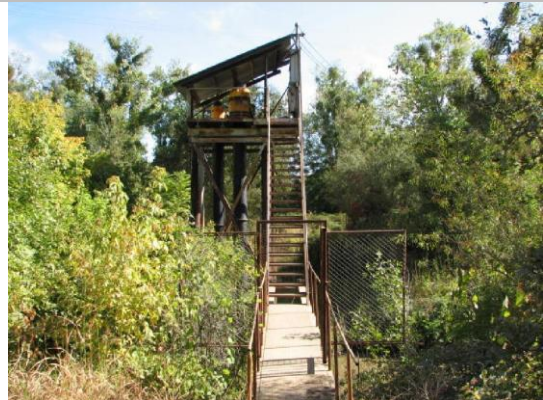
Photo 3 of 3 : UCIP\_FA\_2018\_53408\_64666.jpg

Pumping plant on WS toe at small slough. Pipes no longer connected to concrete box on WS toe.

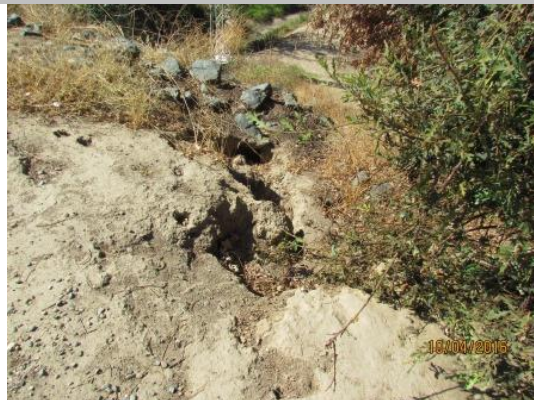
Photo 1 of 1 : FA\_2018\_MA0003\_195\_18\_20180918\_00004.jpg

LM Start	2.18	Rating **	A/W	Issue No.	18
LM End	2.18	Issue Type +	Ma	Location *	LS
Category	Earthen Levee			GPS Latitude/Longitude	
				Start	End
Item	Animal Control			38.911869 °	38.911869 °
				-121.586093 °	-121.586093 °
DWR ID	DWR_MA0003_01_s_2015_18				
Comment Code					
A3 : No rodents visible, but rodent burrows visible; need to backfill and compact or grout burrows.					
Inspector Comment					
No animal activity viewed at time of inspection, Fall 2018.

View of rodent holes that need to be backfilled, No evidence of rodents during inspection. Fall 2016.

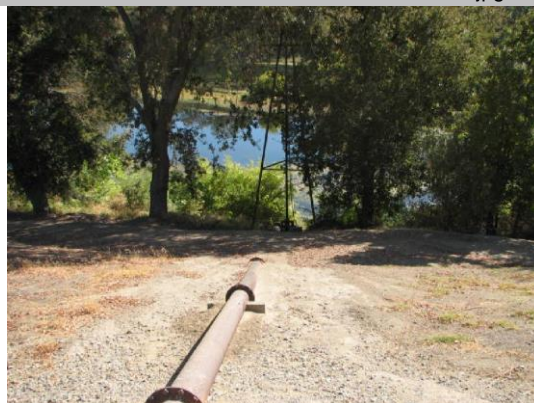
Photo 1 of 3 : UCIP\_FA\_2018\_52788\_64672.jpg

Comment Code					
Inspector Comment					
FS_ID:52788 DS_ID:17087 EP_NO: 1730 Repair Type: Non-Urgent Crossing Status: Found UCIP Comments: 4/11/2017 Big dig out/depression still present at the LS toe. Pipe is set to be replaced during the SBFCA project so depression should be repaired then. (DWR Sutter Yard-AFreitag)10/10/2016 Depression is still present at the LS toe but appears that it was dug out on purpose.(DWR Sutter Yard -afreitag)4/18/2016 Big depression on LS toe along the pipe alignment. 5/12/2015 Crossing appears to be in good condition. No noticeable issues to report.11/17/2014 Same as last inspection.5/14/2014 Same as last inspection.10/30/2013 Same as last inspection.5/21/2013 SBFCA project recommends replacing in accordance with title 23. Same as last inspection. FIELD_STRUCT_DESC: 12-inch asphalt coated steel irrigation pipe through the levee, 4.5 feet below the crown. Gate valve and pump located on the waterside (WS). 24-inch concrete standpipe located on the landside (LS) toe has been degraded to ground elevation and filled in with soil. Pipe remains intact. Steel tower over pump is located on the WS. (Permit No. 1730, 1959 - Robert L. Crandall). [Additional Reference(s): DWR Levee Log, 2005]. FS Date: 4/12/2017 9:16:00 AM

Pipe, pump, and tower on WS slope/toe.

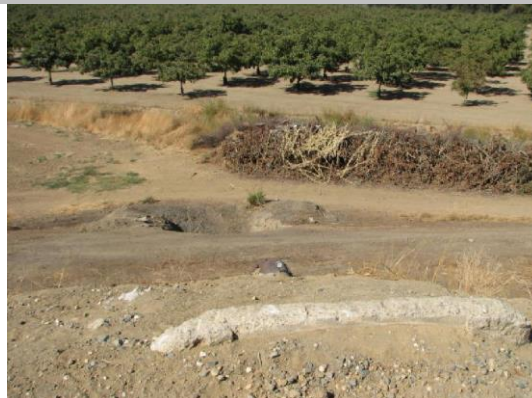
Photo 2 of 3 : UCIP\_FA\_2018\_52788\_64671.jpg

Comment Code						
Inspector Comment						
FS_ID:52788 DS_ID:17087 EP_NO: 1730 Repair Type: Non-Urgent Crossing Status: Found UCIP Comments: 4/11/2017 Big dig out/depression still present at the LS toe. Pipe is set to be replaced during the SBFCA project so depression should be repaired then. (DWR Sutter Yard - A Freitag)10/10/2016 Depression is still present at the LS toe but appears that it was dug out on purpose.(DWR Sutter Yard - A Freitag)4/18/2016 Big depression on LS toe along the pipe alignment. 5/12/2015 Crossing appears to be in good condition. No noticeable issues to report.11/17/2014 Same as last inspection.5/14/2014 Same as last inspection.10/30/2013 Same as last inspection.5/21/2013 SBFCA project recommends replacing in accordance with title 23. Same as last inspection. FIELD_STRUCT_DESC: 12-inch asphalt coated steel irrigation pipe through the levee, 4.5 feet below the crown. Gate valve and pump located on the waterside (WS). 24-inch concrete standpipe located on the landside (LS) toe has been degraded to ground elevation and filled in with soil. Pipe remains intact. Steel tower over pump is located on the WS. (Permit No. 1730, 1959 - Robert L. Crandall). [Additional Reference(s): DWR Levee Log, 2005]. FS Date: 4/12/2017 9:16:00 AM

Pipe at LS shoulder showing exposed concrete cutoff wall.

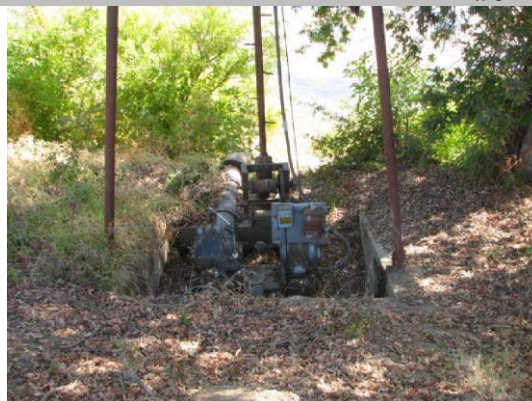
Photo 3 of 3 : UCIP\_FA\_2018\_52788\_64670.jpg

Pump at WS toe with tower over top and concrete U shaped headwall.
